DEPARTMENT OF TRANSPORTATION

Quality Assurance and Source Inspection

Contract #: 04-0120F4Cty: SF/ALA Rte: 80 PM: 13.2/13.9File #: 99.28**WELDING INSPECTION REPORT****Resident Engineer:** Casey, William**Address:** 333 Burma Road**City:** Oakland, CA 94607**Report No:** WIR-027666**Date Inspected:** 30-May-2012**Project Name:** SAS Superstructure**OSM Arrival Time:** 700**Prime Contractor:** American Bridge/Fluor Enterprises, a JV**OSM Departure Time:** 1330**Contractor:** F & M Fabricators**Location:** jobsite**CWI Name:** Mark Nelson**CWI Present:** Yes No**Inspected CWI report:** Yes No N/A**Rod Oven in Use:** Yes No N/A**Electrode to specification:** Yes No N/A**Weld Procedures Followed:** Yes No N/A**Qualified Welders:** Yes No N/A**Verified Joint Fit-up:** Yes No N/A**Approved Drawings:** Yes No N/A**Approved WPS:** Yes No N/A**Delayed / Cancelled:** Yes No N/A**Bridge No:** 34-0006**Component:** SAS project**Summary of Items Observed:**

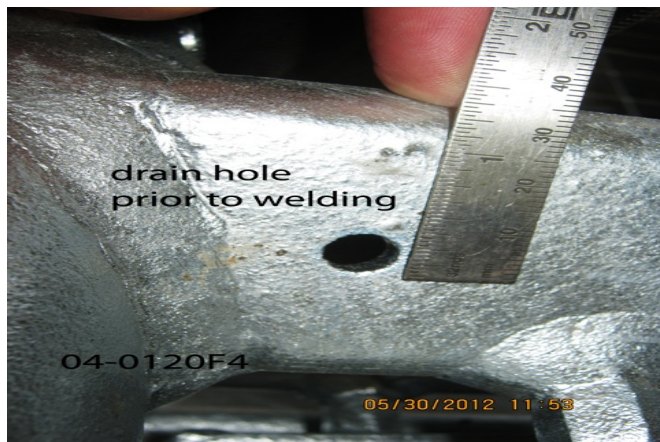
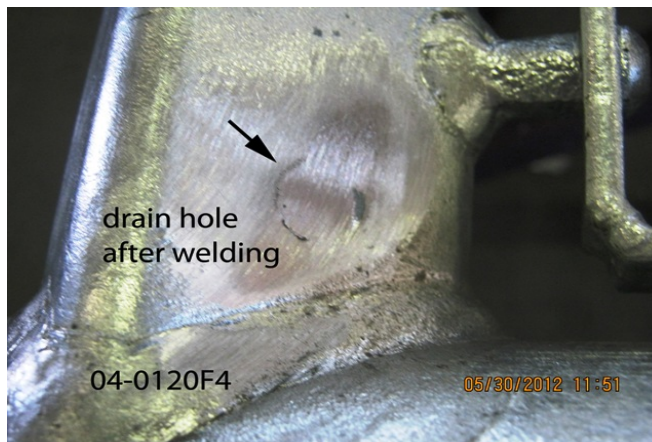
This QA Inspector randomly observed F & M welding personnel Manuel Ramirez using the Flux Cored Arc Welding (FCAW) process on galvanized metal to fill open holes in the various piping and tubing used to fabricate the bike path hand rails. This QA Inspector observed the holes were approximately 1/4-inch in diameter and the weld joint did not include backing and the configuration of the material did not permit access for back gouging. The weld joint did not appear to comply with a prequalified weld joint detail in AWS D1.1-2002. This QA Inspector observed the welding was being performed prior to the removal of the hot dipped galvanizing material. This QA Inspector spoke with F & M representative Mark Nelson, requesting a Welding Procedure Specification (WPS) for the welding being performed and was informed that one was not available. This QA Inspector was also informed the welding personnel qualification documents had not been made available to the Caltrans Engineer, prior to the start of this welding. This QA Inspector informed Structural Material Representative Nicolai Hvass of the issues noted above and was informed to issue an Incident Report documenting the observations. See photos below of galvanizing drain holes in the tops of rails both prior to welding and after welding. This QA Inspector observed only approximately 2-3 railings had been welded this date.

was informed by F & M Fabricator representative Mark Nelson he intended to use this material to repair the galvanized surfaces disturbed by the welding process. This QA Inspector informed F & M Fabricator representative Mark Nelson the use of a spray coating was not approved by Caltrans and suggested he check the Caltrans website for an approved product. This QA Inspector observed as F & M Fabricator representative Mark Nelson went to the Caltrans website for a list of the approved products. Mr. Nelson implied he would acquire one of the prequalified coatings for galvanizing repair. This QA Inspector did not observe personnel using the spray can material this date.

This QA Inspector observed an F & M Fabricator employee gluing on several of the PTFE pads onto the galvanized metal surfaces using a glue not specified on the approved drawing. This QA Inspector observed note #5, in the general notes on approved drawing SKY-179-A-1, Revision-1 stated the following; "PTFE shall be bonded to uncoated steel surfaces." and "Loctite 770 primer or EQ. shall be applied to etched bond-side of the PTFE. Loctite 401 bonding agent or EQ. shall be applied onto the mating steel surface.". F & M Fabricator representative Mark Nelson informed this QA Inspector he was using glue "Bondit B-45 TH" specified on Caltrans Plans drawing titled Skyway Cleanup Items, Modified bike Path railing Details No.1, sheet # 1164525R1. This QA Inspector reviewed the drawing and observed it was a Caltrans Plan drawing for a different Contract Change Order (CCO) (#219). This QA Inspector implied the approved shop drawings supersede the plan drawings and suggested a Request For Information (RFI) could be submitted regarding cluing the PTFE over the galvanized (coated) metal and could provide documentation showing the glue he was using was equivalent to the glue specified.
